Aviation Safety

Maintainer

Issue 4/2000

Large Aircraft Cowl Fastener Problems

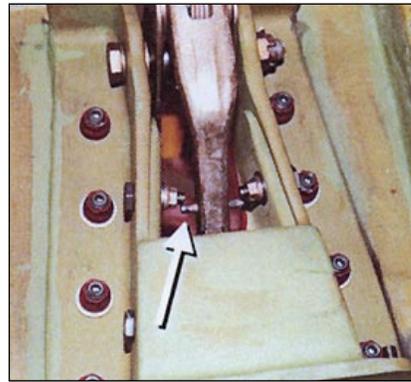
Latch subassemblies with bolts installed in opposite orientations.

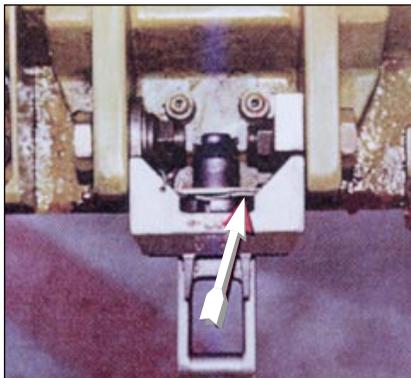
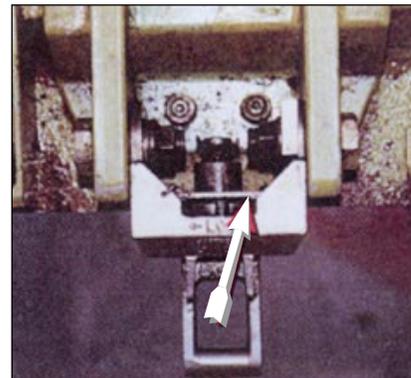
Normal and failed star-adjustment retention springs.

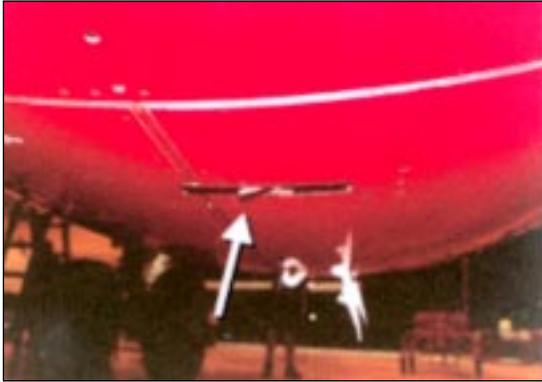
Incomplete trigger/safety engagement on A320 engine fan cowl.

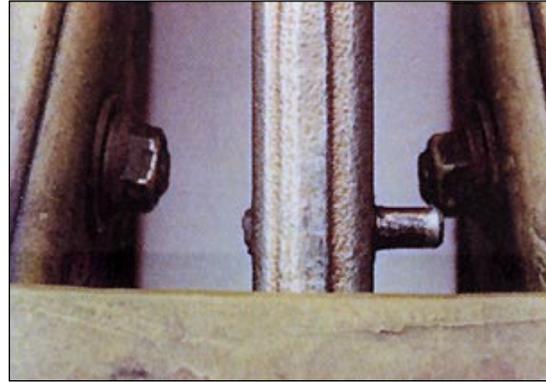
Damaged latch subassembly from the occurrence aircraft.

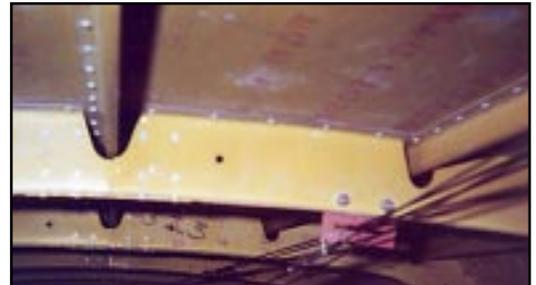
The above photo illustrates the area where the pigtail was catching on the fairlead during operation of the trim control.

stiff. When the wheel was actuated in the reverse direction, something broke free with a resounding “thud.” Upon further investigation I discovered that an incorrectly lockwired turnbuckle was hooking on an adjacent fairlead in the area above the baggage compartment. Since the area is rather hard to access, it appeared that the person locking the turnbuckle looked at the easiest method and used wire twisters to lock the turnbuckle, leaving a large “pigtail” sticking out to interfere with the operation of the trim control as it passed through the fairlead. Further research revealed that Advisory Circular (AC) 43-13-1b illustrates five methods of safetying turnbuckles, none of which use twisted wire pigtails. The moral of the story is to refer to the manufacturer’s recommendations or equivalent. If no specification is made, use standard industry practice and reference material, such as AC 43-13-1b, the reference that would have required a different procedure from the incorrect one used in this case. 🙏

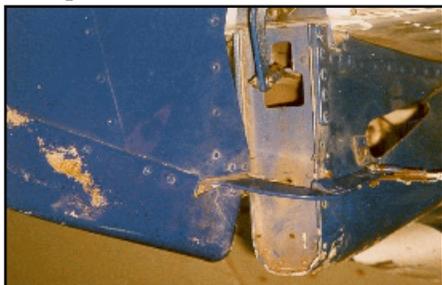
The Transportation Safety Board Lab (TSB) report observed, among other points, that the rudder stop plate on the right-hand half of the rudder horn was firmly jammed behind its stop bolt on the fuselage. The rudder was deflected 34° measured perpendicular to the hinge line, whereas the maximum allowable deflection for setting the stops is 23°. When the rudder was released from its jam, the deflection was 23°. It required 36 lb of steady pull on the trailing edge of the rudder to break the rudder out of its jammed position. This steady pull of 36 lb equated to 180 lb if the force was applied to the

rudder pedal. However, given that the direction of cable pull tended to increase the jamming by closing the horn, it would not have been possible for the pilot to break the rudder jam by applying the right rudder.

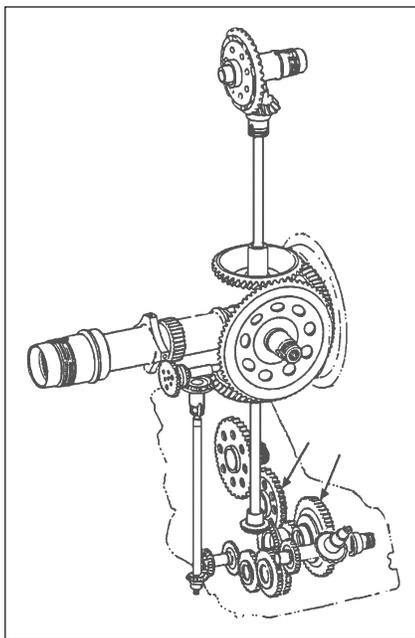
The TSB investigation revealed broken teeth on the accessory drive gears as depicted (arrows).

The wear pattern on the gears suggested that there was a misalignment of the gears. It was also noted that the bearing liner bolts lost their torque, and the bearing liner had been moving in the cover bore. There was evidence of fretting between the bolts and the liner. The gearbox case and cover support bores were measured in a co-ordinate measuring machine to determine their size and true location. Five other used gearboxes were also measured for comparison. Most of the examined gear boxes had excessive wear and misalignment, including some greater than the failed gearbox, but none had failed gears. Subsequent to this failure, the company conducted tests and found that the value of the bolt installation torque falls after a couple of hours. This loss of torque is a result of an O-ring squeezing out

from behind the bearing liner and the case. Insufficient torque allowed the bearing liner to move and cause wear in the bore. This is probably the mechanism that led to misaligned bearing bores and abnormal wear of the gear teeth. As a result, the company overhaul procedures have been modified to reduce the bolt torque loss. Allied Signal has recently issued Service Bulletin No. T5508D-0042 advising customers of a procedure for measuring alignment of the accessory gearbox case and cover bores.

Inspection and failure analysis of the accessory gearbox input spur gear using scanning electron microscopy and optical microscopes determined that the gear failed as a result of manufacturing defects. The spur gear was abnormal; it had been manufactured with an extremely hard and brittle surface that contained networks of microcracks. It was also found that the critical root zone had course machining or grinding marks. The mode of failure was fatigue, which initiated at several locations associated with the pre-existing microcrack networks. The fatigue fracture was not in the gear tooth contact areas. The abnormal loads placed on the gear teeth as a result of misalignment may have been a secondary factor in the gear failure. 🛠️
